Michigan Clear Vision Home Inspections  
1234 Company Lane  
Waterford , US 48327

123 Some Street  
Somewhere, US 12345

# Michigan Clear Vision Home Inspections

19:13 January 20, 2022

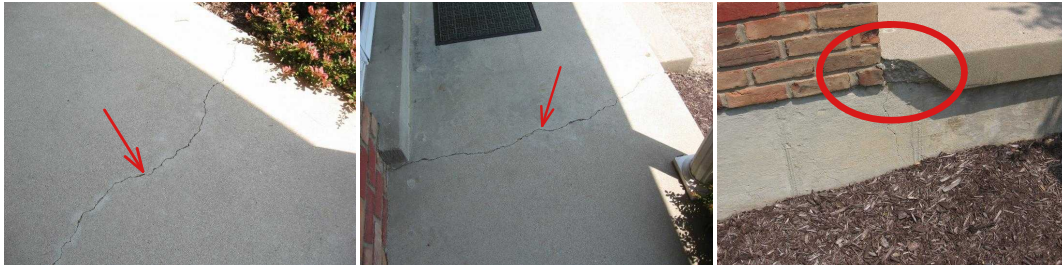
Acceptable Driveway: Concrete  
Acceptable Walks: Concrete  
Defective Porch: Concrete - **Settling away from foundation with surface cracks noted**

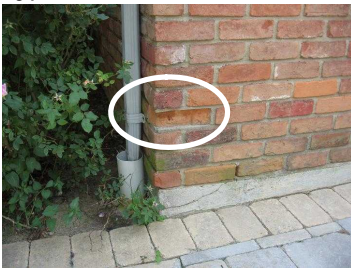
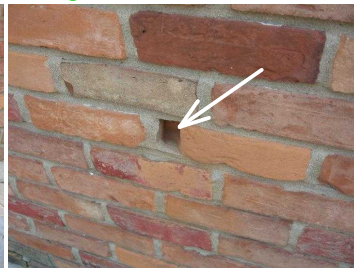
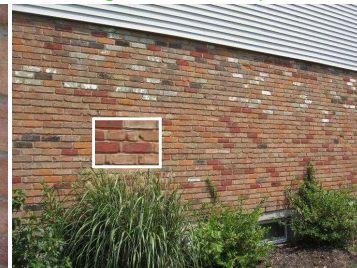
Marginal Type: Brick veneer - Some damaged bricks, Recommend sealing brick with penetration sealer products

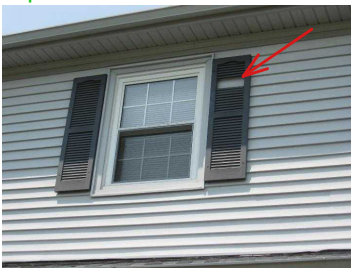
Marginal Type: Vinyl siding - Damaged front shutter, Chalking noted due to age, One panel needs to be repositioned at rear elevation

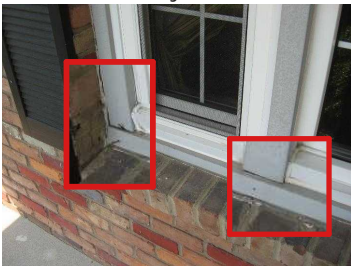
Marginal Windows: Vinyl insulated - Reseal caulking at window perimeters at brick window openings

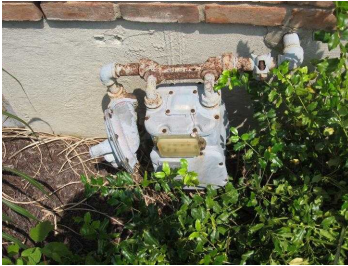
Acceptable Exterior Electric Outlets: 110 VAC GFCI  
Marginal Hose Bibs: Gate - **Properly secure fixture(s) to exterior wall with fasteners**  
Acceptable Gas Meter: Exterior surface mount at side of home - Rust present, Keep bushes and shrubs away from meter

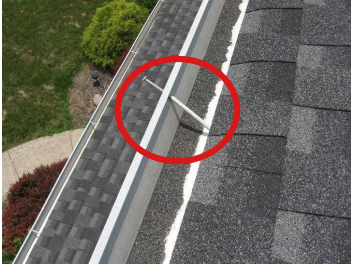
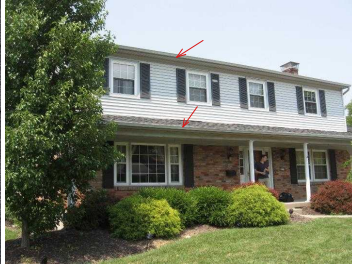
Gutters: Aluminum - Loose nails, Sagging gutters at front and rear

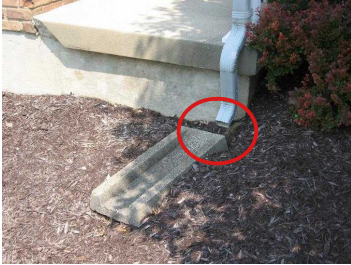
Downspouts: Aluminum  
Leader/Extension: Splash blocks - Splash block(s) not properly installed

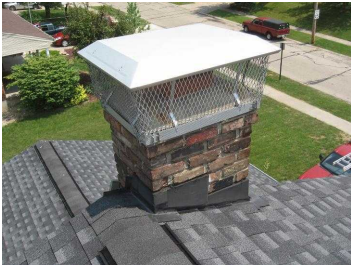
Not Inspected Flue/Flue Cap: Clay tile - Weather cap obstructed view of flue

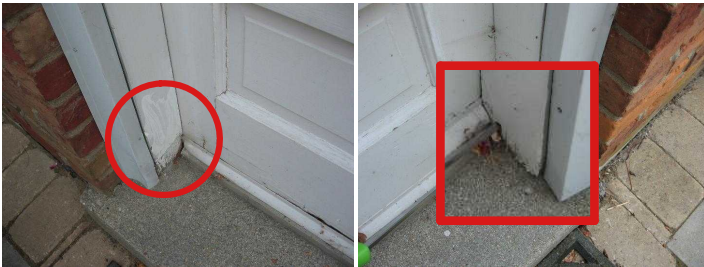
Defective Service Doors: Wood - **Wood rot at bottom of door and frame**

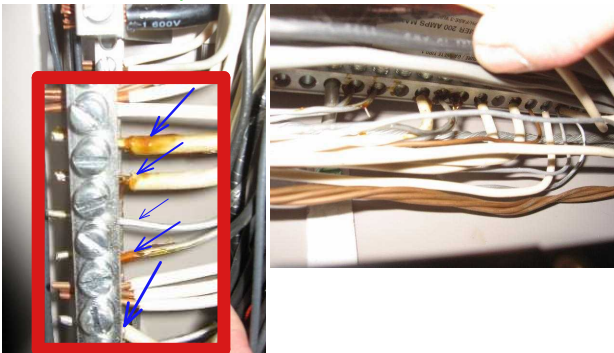
Marginal Aluminum Wiring: Present at several circuits - **Aluminum branch wiring has had a history of problems relating to poor connections due to galvanic corrosion, dissimilar metals, brittle conductors and type of aluminum alloy used during the time period of 1965 through 1972. These problems create unsatisfactory conditions at connections and splice locations and therefore create potential fire hazards. Recommend wiring update for aluminum wiring by a licensed electrician, Circuits are recommended to be upgraded with special compression type connectors at splices and branch circuits to reduce the potential risks of aluminum branch wiring.(Cop-Alum Crimp System)**

Marginal 120 VAC Branch Circuits: Copper and aluminum - **Evaluation by a licensed electrician is recommended, See aluminum wiring notes below**

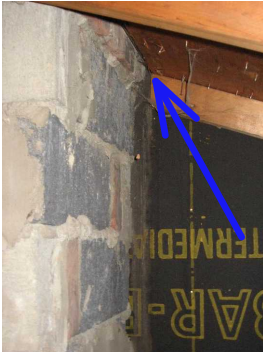
Marginal Roof Framing: 2x3/4 Truss - Wood blocking components missing at chimney perimeter

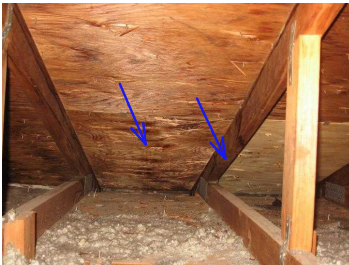
Marginal Sheathing: Plywood - Water stains and slight damage present, Areas of sheathing have been repaired

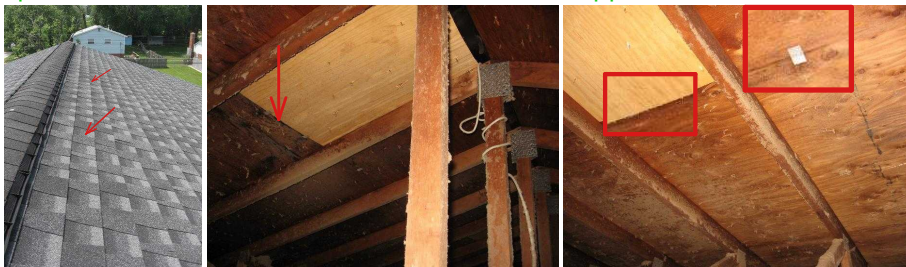
Acceptable Roof Framing: 2x3/4 Truss  
Marginal Sheathing: Plywood - Poor repair at 2 areas near ridge at rear slope - No H clips installed and repair only spanned one truss - Recommend additional support be installed

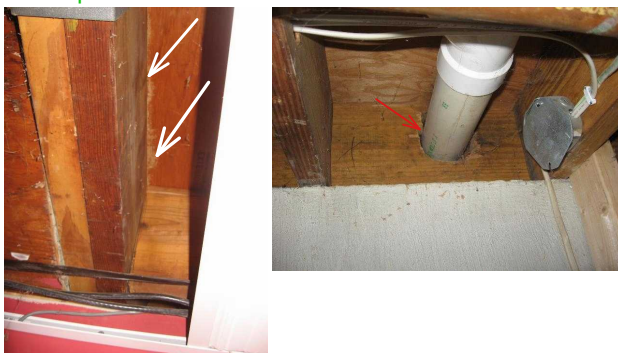
Acceptable Structure Type: Wood frame  
Acceptable Foundation: Poured concrete  
Acceptable Differential Movement: Slight settlement present - Minor settlement at front porch, Cracks will require monitoring  
Acceptable Beams: Steel I-Beam  
Acceptable Bearing Walls: Wood frame  
Marginal Joists/Trusses: 2x10 - Areas not visible due to ceiling finishes or other obstructions, Framing joist near fireplace chimney shows evidence of previous termite infestation - No repairs required, Seal penetration as required

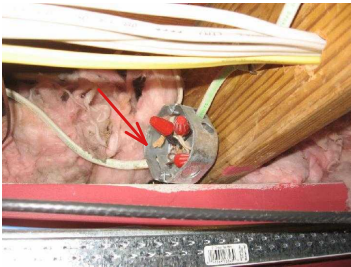
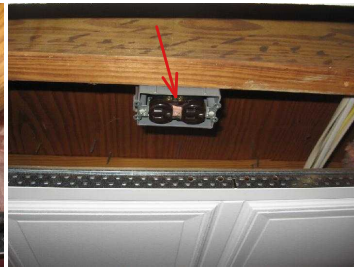
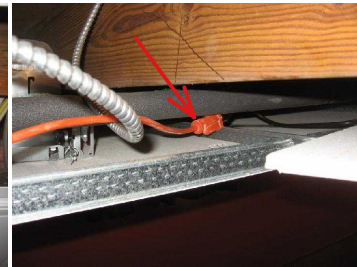
Marginal Electrical: 110 VAC - **Loose junction boxes, missing and mis-sized covers, extension cord wiring to projector**

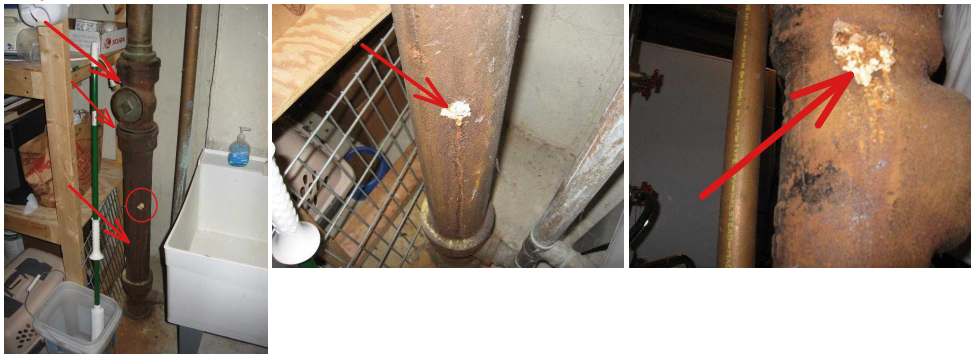
Defective Drain Pipes: Cast iron, Copper - **Pitting cast iron drain piping stack - replace affected sections where required**

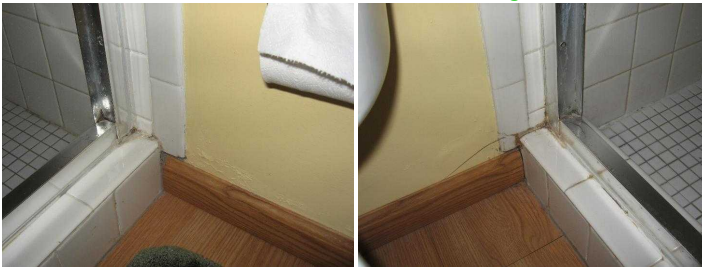
Marginal Shower/Surround: Ceramic tile - **Leaking at corner of door frame**

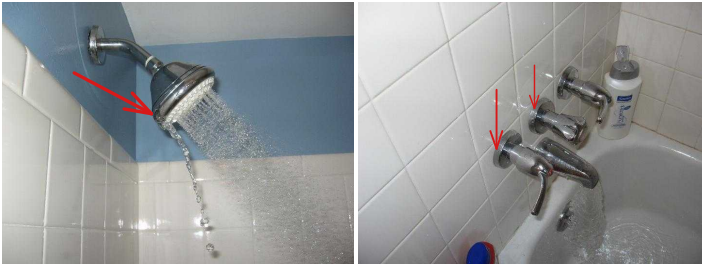
Marginal Closet: Large - **Alignment needed at closet doors**  
Acceptable Ceiling: Drywall  
Acceptable Walls: Drywall  
Marginal Floor: Laminated flooring - **Gapping noted in planks**  
Acceptable Doors: Hollow wood  
Acceptable Windows: Vinyl Insulated  
Acceptable Electrical: GFCI  
Acceptable Counter/Cabinet: Wood  
Acceptable Sink/Basin: One piece sink/counter top  
Defective Faucets/Traps: Delta fixtures with a metal trap - **Leaking shower head, Loose trim rings**

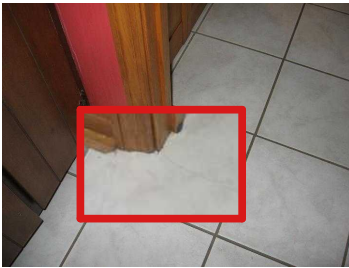
Floor: Ceramic tile - **Cracked tile noted**

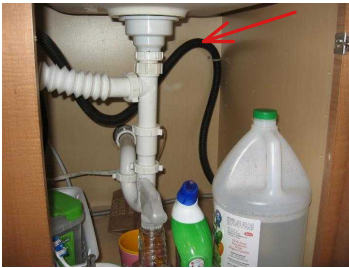
Acceptable Cooking Appliances: Frigidaire  
Acceptable Disposal: General Electric  
Marginal Dishwasher: Maytag - Properly secure the dishwasher discharge hose so that it creates a "high loop" above the basin drain to minimize food or water backup under dishwasher

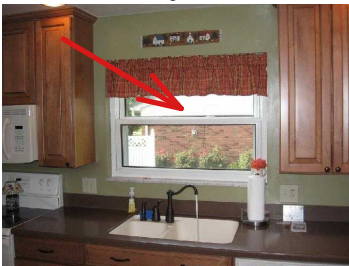
- Acceptable Refrigerator: Amana
- Acceptable Microwave: General Electric
- Marginal Sink: Stainless Steel - **Chipping at drain**
- Acceptable Electrical: 110 VAC GFCI
- Acceptable Plumbing/Fixtures: Stainless Steel
- Acceptable Counter Tops: Solid Surface
- Acceptable Cabinets: Wood - Loose cabinet door hinges
- Acceptable Pantry: Large
- Acceptable Ceiling: Drywall
- Acceptable Walls: Drywall
- Acceptable Floor: Ceramic tile
- Acceptable Doors: Hollow wood
- Defective Windows: Vinyl Insulated - **Insulated glass unit seal failure**

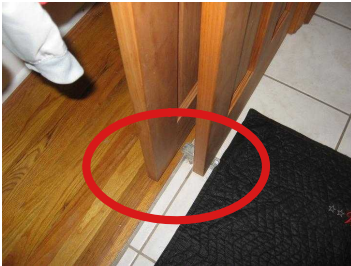
Marginal Closet: Various - **Missing door glides at bypass closet door in Foyer**

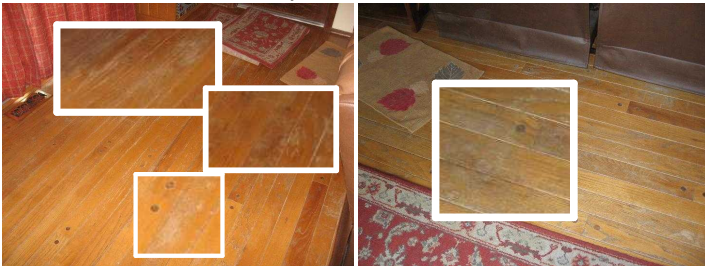
Ceiling: Drywall  
Walls: Drywall  
Floor: Ceramic tile, Carpet, Hardwood - **Worn wood finish in Family room**

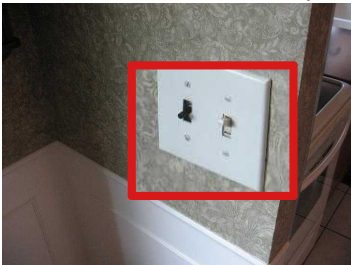
Doors: Solid wood  
Windows: Vinyl Insulated  
Electrical: 110 VAC - Replace missing dimmer switch in Dining room

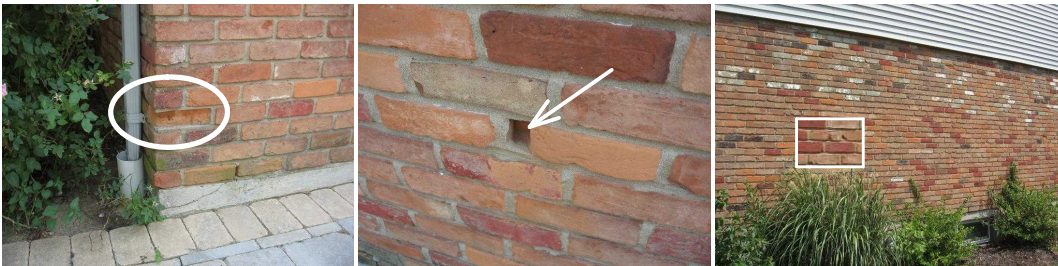
2. 1st Floor Exterior Surface Type: Brick veneer - **Some damaged bricks, Recommend sealing brick with penetration sealer products**

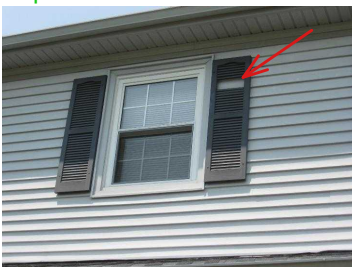
3. 2nd Floor Exterior Surface Type: Vinyl siding - **Damaged front shutter, Chalking noted due to age, One panel needs to be repositioned at rear elevation**

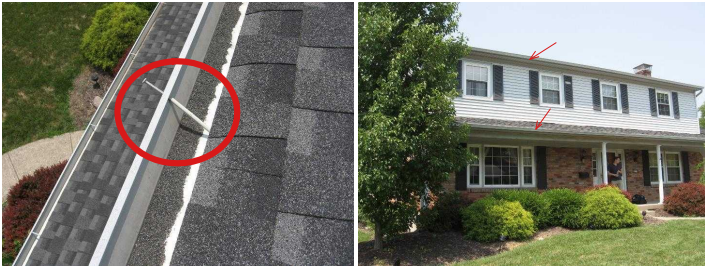
9. Gutters: Aluminum - Loose nails, Sagging gutters at front and rear

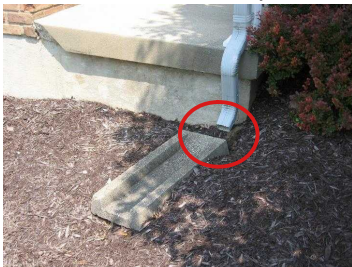
10. Leader/Extension: Splash blocks - Splash block(s) not properly installed

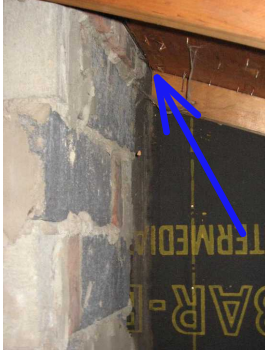
16. Attached Garage Attic Roof Framing: 2x3/4 Truss - Wood blocking components missing at chimney perimeter

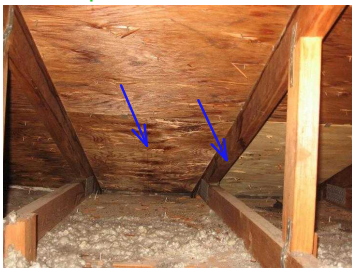
17. Attached Garage Attic Sheathing: Plywood - Water stains and slight damage present, Areas of sheathing have been repaired

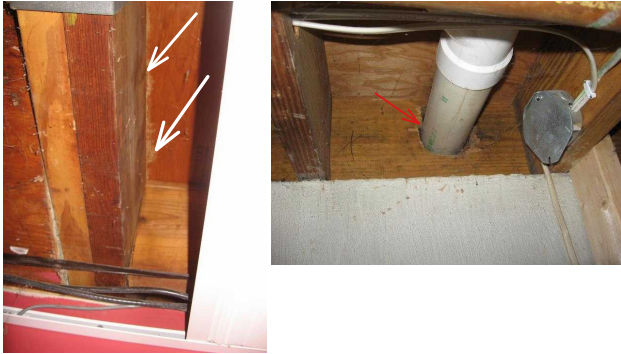
19. Joists/Trusses: 2x10 - Areas not visible due to ceiling finishes or other obstructions, Framing joist near fireplace chimney shows evidence of previous termite infestation - No repairs required, Seal penetration as required

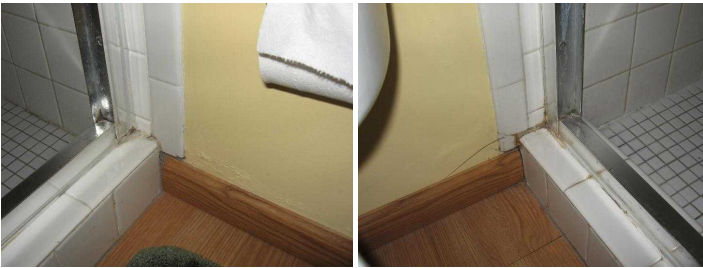
23. Master Bathroom Shower/Surround: Ceramic tile - **Leaking at corner of door frame**

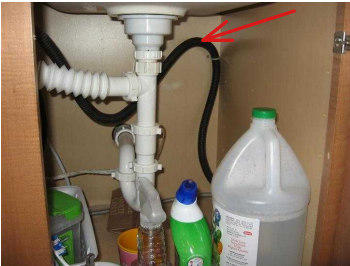
27. 1st Floor Kitchen Dishwasher: Maytag - **Properly secure the dishwasher discharge hose so that it creates a "high loop" above the basin drain to minimize food or water backup under dishwasher**

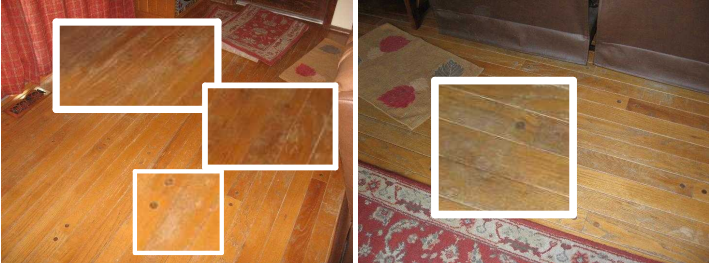
30. 1st Floor Living Space Floor: Ceramic tile, Carpet, Hadwood - Worn wood finish in Family room

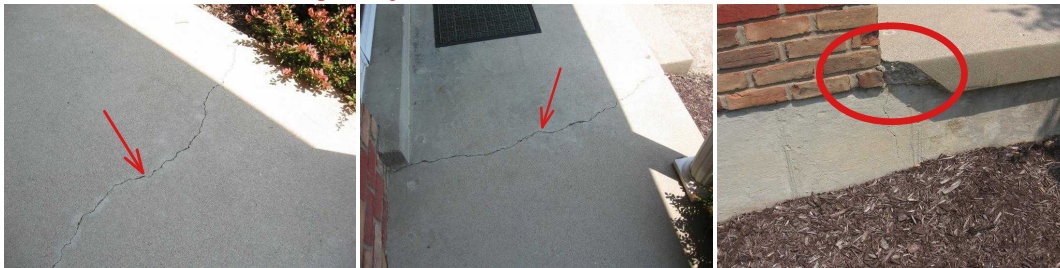
1. Porch: Concrete - **Settling away from foundation with surface cracks noted**

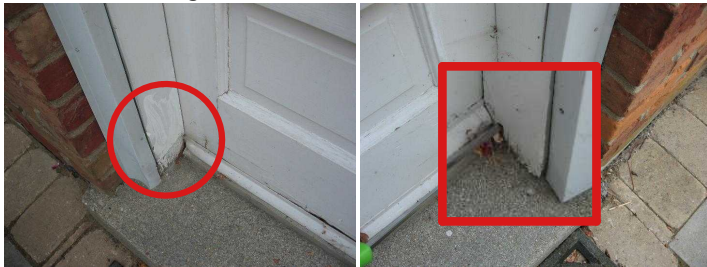
2. Attached Garage Service Doors: Wood - **Wood rot at bottom of door and frame**

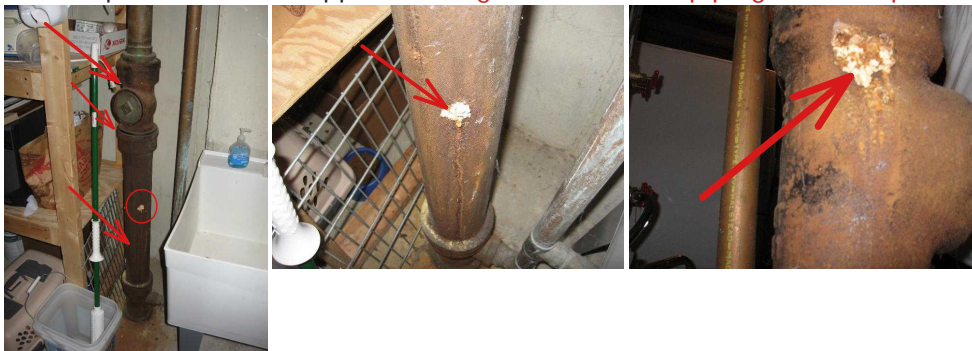
4. Drain Pipes: Cast iron, Copper - **Pitting cast iron drain piping stack - replace affected sections where required**

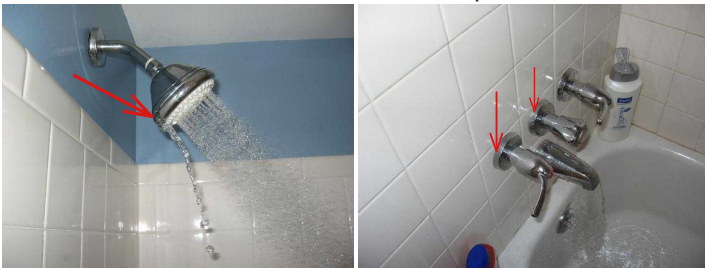
5. 2nd Floor Hall Bathroom Faucets/Traps: Delta fixtures with a metal trap - **Leaking shower head, Loose trim rings**

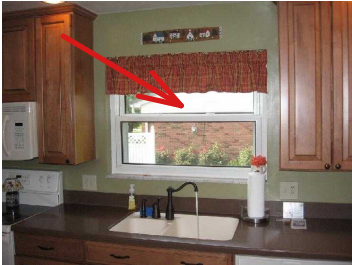
6. 1st Floor Kitchen Windows: Vinyl Insulated - **Insulated glass unit seal failure**
