Michigan Clear Vision Home Inspections  
1234 Company Lane  
Waterford , US 48327

123 Some Street  
Somewhere, US 12345

# Michigan Clear Vision Home Inspections

19:13 January 20, 2022

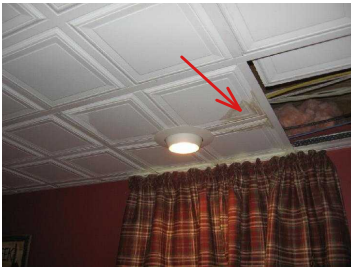
### Main Basement

Acceptable Ceiling: Suspended Acoustical System - Evidence of past water staining

Marginal Floor: Carpet - **Carpet stains noted**

Marginal Electrical: 110 VAC - **Loose junction boxes, missing and mis-sized covers, extension cord wiring to projector**

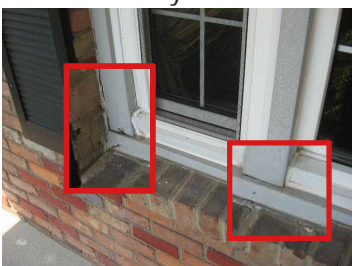
4. Trim: Aluminum - **Chalking noted due to age, Loose nails in areas**
5. Soffits: Vinyl - **Loose/sagging at front porch**
6. Patio Door: Vinyl sliding - **Resecure loose handle hardware, Screen damage noted**
7. Windows: Vinyl insulated - **Reseal caulking at window perimeters at brick window openings**

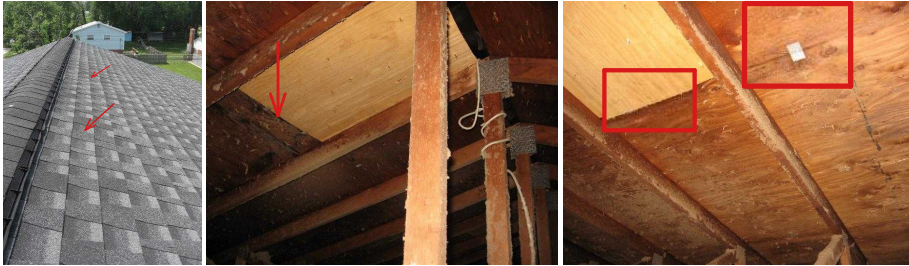
19. Joists/Trusses: 2x10 - Areas not visible due to ceiling finishes or other obstructions, Framing joist near fireplace chimney shows evidence of previous termite infestation - No repairs required, Seal penetration as required

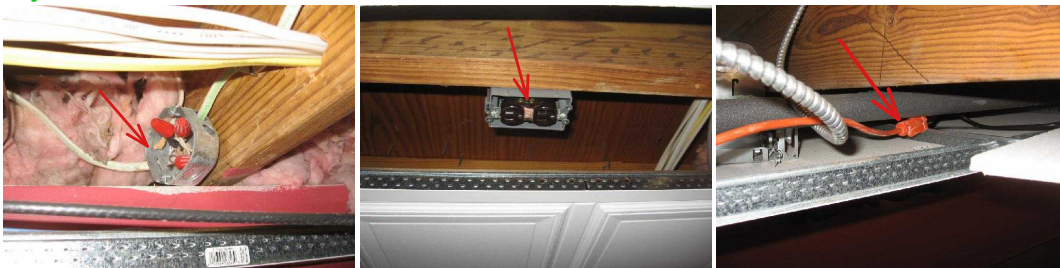
20. Main Basement Floor: Carpet - Carpet stains noted  
21. Main Basement Electrical: 110 VAC - Loose junction boxes, missing and mis-sized covers, extension cord wiring to projector

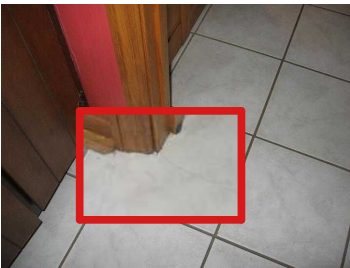
24. 2nd Floor Hall Bathroom Closet: Large - **Alignment needed at closet doors**  
25. 2nd Floor Hall Bathroom Floor: Laminated flooring - **Gapping noted in planks**  
26. 1st Floor Hall Half Bathroom Floor: Ceramic tile - **Cracked tile noted**

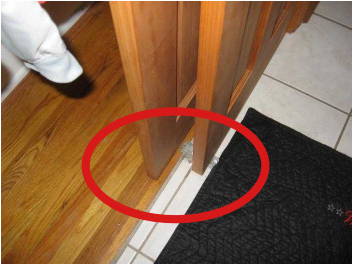
30. 1st Floor Living Space Floor: Ceramic tile, Carpet, Hadwood - Worn wood finish in Family room
